Manhole Inspection Summary

Manhole # S25CC_063MH

Insp Date: **7/19/07 10:24 AM**

Location Address: **1203 SMITHSON ST**

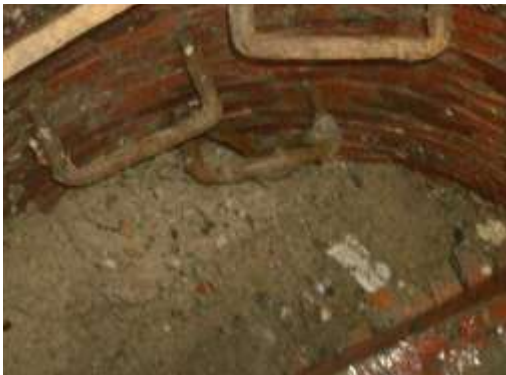
Defect 3

☒ **Evidence Of Surcharge** Depth: **3** (ft.) ☐ Active Surcharge Present

surcharge evidence on the bottom step

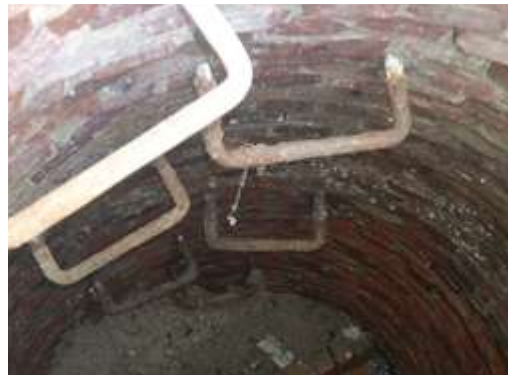
Defect 2

Count: **6** Missing: **0** ☒ **Corroded**

corroded steps

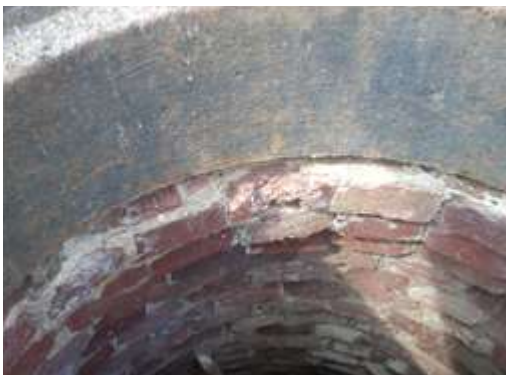
Defect 1

Condition: ☐ Sound ☐ Cracked ☐ Root Intrusion ☐ Loose Brick ☒ **Deteriorated**

deteriorated corbel

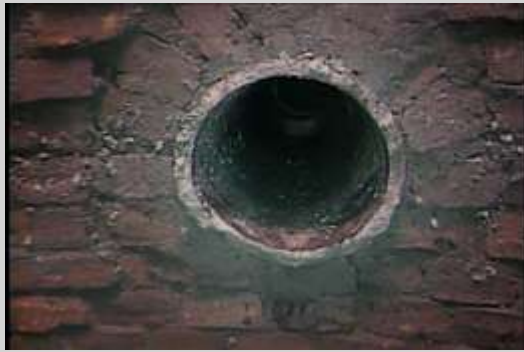
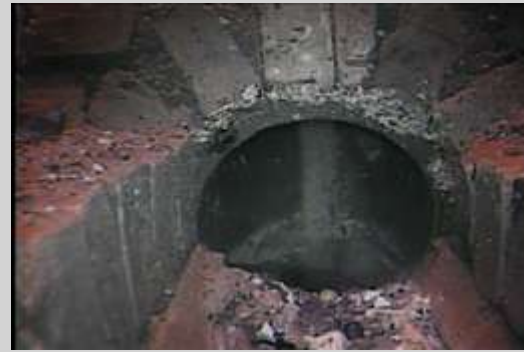
6 O'Clock Inflow

Deposits: ☐ None ☐ Mud ☐ Sludge ☒ **Debris** ☐ Grease

Silt Depth: **1** (in.) Deposits Extent: **Light**
